BULLETINFONTAINE

TB-064 • September 2016

Fontaine ARMOR[™] cold weather maintenance

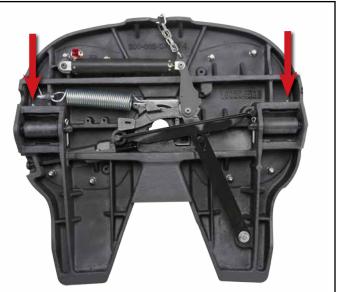
Figure 1: Top view, lubrication points of Fontaine Armor

Once the fifth wheel has been properly degreased, lubrication can be applied to critical areas of the fifth wheel. As the red lines **Figure 1** indicates, grease should be applied to the locking jaw and the stationary jaw as well as to the wear plates of a closed fifth wheel. Distribute the grease along the full length of the components.

When low temperatures occur, Fontaine[®] Parts Connection suggests that the grease be removed from the fifth wheel (steam cleaning is preferred) and new grease applied. Follow safety precautions by disarming the fifth wheel before performing maintenance. It is especially important that the throat of the fifth wheel be cleaned and cleared of any and all debris (ice, snow, sludge, rock, etc.) that could prevent correct coupling. In addition, hardened grease should be removed from the grease grooves and angled surfaces of the wear plates.

During cold weather, Fontaine recommends the use of a lightweight lubricant. Using NLGI grades 000 or 00 (e.g. Mobilith SHC 007) will help ensure proper movement and lubrication of the locking mechanism. Fontaine suggests contacting your specific lubricant manufacturer for guidelines on mixing compatibility of any lubricant. Fontaine recommends preventative fifth wheel maintenance every 500 hours during the winter months.
